**GEO-TECHNICAL AND GEO-
ENVIRONMENTAL REPORT**
PROPOSED RESIDENTIAL DEVELOPMENT
HEOL Y GLYN
GLYN-NEATH

Report No. 10287

REPORT TITLE : **Geo-Environmental and Geo-Technical**
Report: Heol y Glyn, Glyn-Neath

DATE : **May 2008**

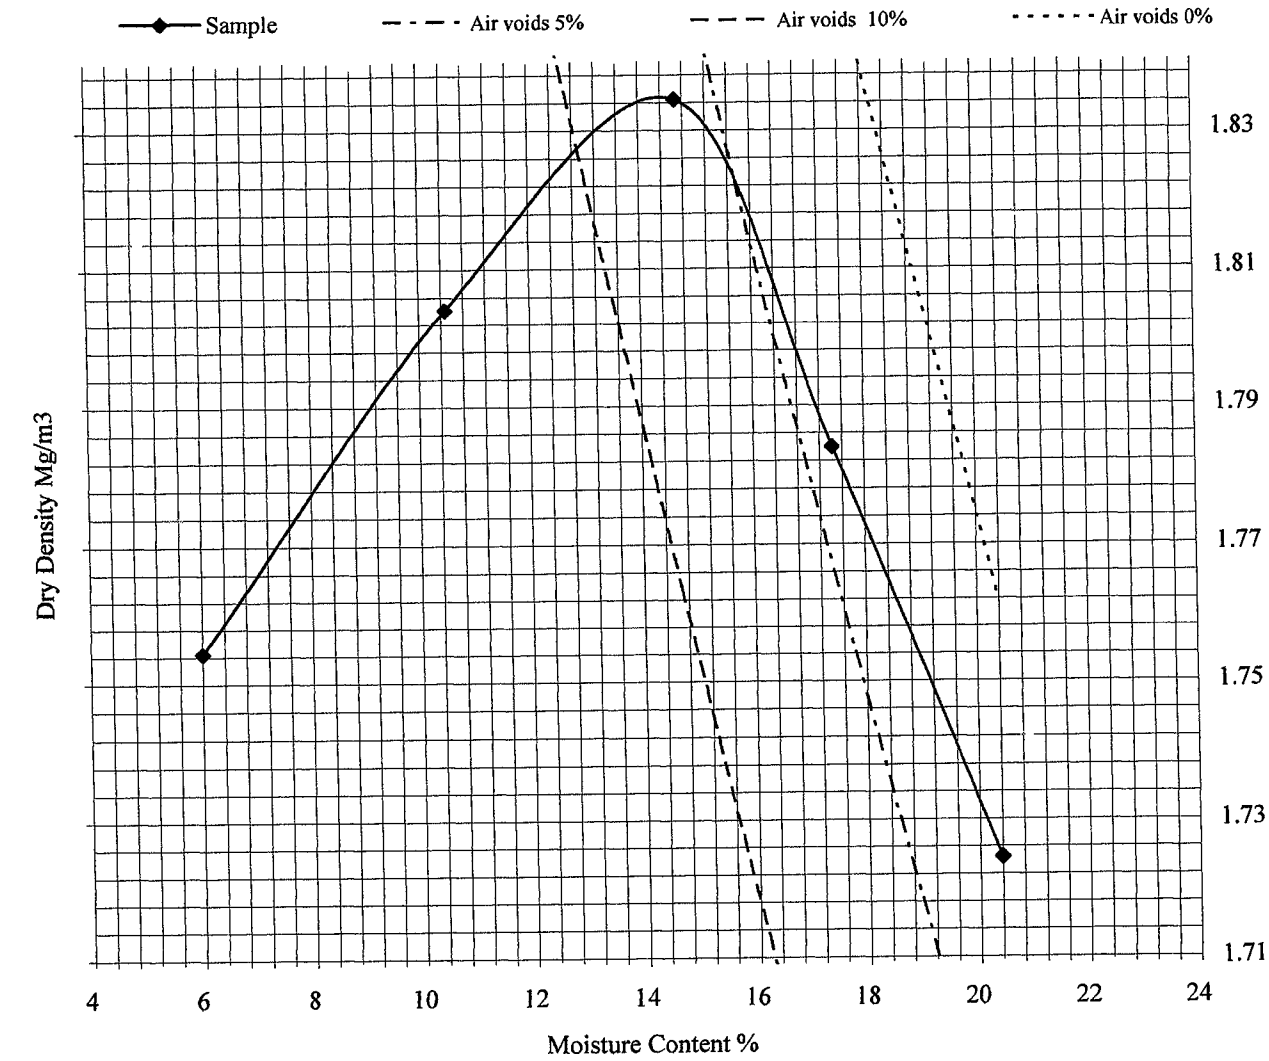
Hole Number: TP6 Depth(m): 3.20

Table with 4 columns: Parameter, Value, Method of Compaction, and Additional Info. Rows include Initial Moisture Content (17), Particle Density (2.75*), Maximum Dry Density (1.83), and Optimum Moisture Content (15).

Table 8.1 Optimum Moisture Content/Maximum Dry Density Test Results			
Sample	Initial Moisture Content (%)	Optimum Moisture Content (%)	Maximum Dry Density(mg/m ³)
TP1	17	15	1.84
TP2	17	14	1.82
TP5	16	13	1.84
TP6	17	15	1.83
