This document provides evidence that the Neath Port Talbot Council has breached the Environmental Protection Act 1990 and has thereby placed the lives of Glynneath residents at risk from 2008 to date by not adhering to the council's responsibilities relating to contaminated land as defined in the 2005 Neath-Port Talbot Council Contaminated Land Strategy.

Land south of Heol y Glyn Site History / Background

Contaminated Land Identified and information submitted to NPTC on 26/11/2008

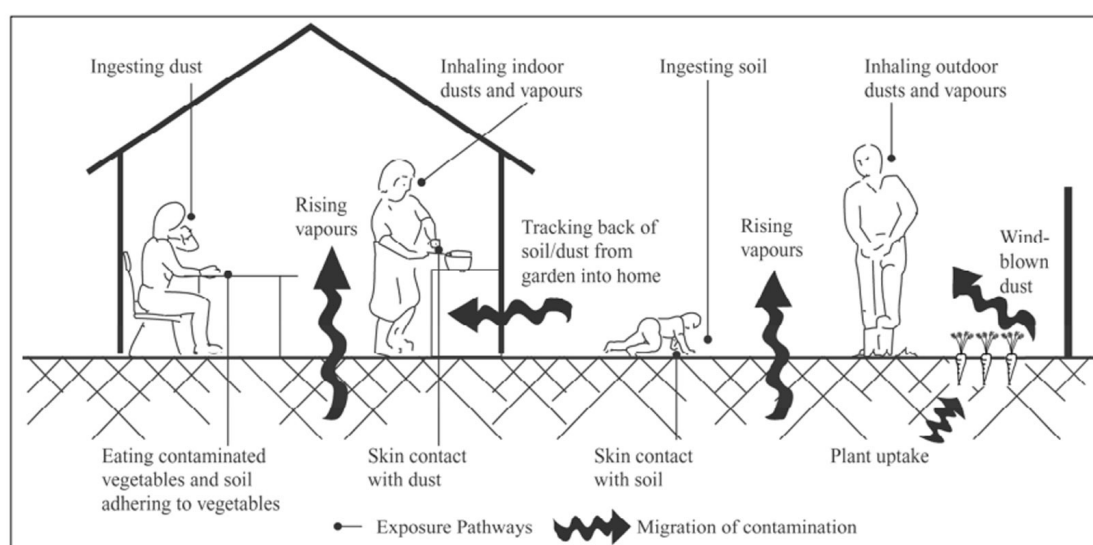
Figure 2.1: Illustration of the potential exposure pathways in the CLEA model

Figure 2.1, the illustration above is from the Environment Agency publication "[Using Science to create a better place - Updated technical background to the CLEA model](#)" it shows the potential exposure pathways for the migration of contamination from soil to human. The figure on the right showing a man working in the garden is particularly relevant to the Heol y Glyn site.

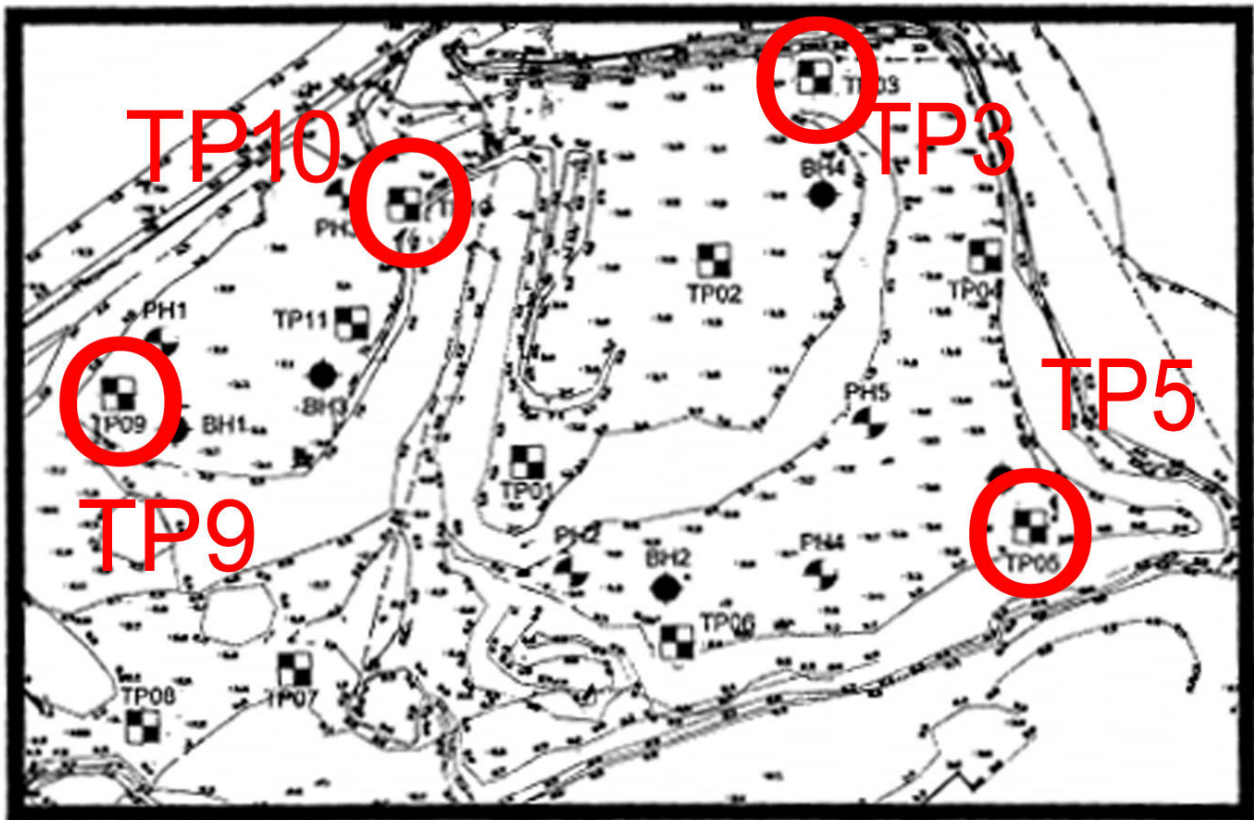
20090710a-DO-ENVI-hist.rpt.cuddy.p116

The land was found to be contaminated at points TP3, 5, 9 and 10 (see illustration above) with the majority of those points all being close to the edge of the development and near to local residents properties. In some instances, the contaminated land testing site can be found less than 20 metres from a neighbouring property. The report advised that dust suppression and a boundary fence were necessary to keep the contaminants from affecting local residents, but since this report was withdrawn and the contamination left unremediated, dust and vapours have been regularly blown towards the houses of residents living next to the site while the Cuddy Group tipped industrial waste. This dust has affected the health of some residents, several of whom have asthma, there are also incidences of children born with mutations and young adults dying from cancer. Some of these young adults used the area of the site known locally as 'the bog' as a play area during childhood. The figure below shows the direction of the ground water flowing downhill toward the stream and wetlands area of the development site. Water in the bog area would have flowed down from the tipped material at the site and it is probable that this ground water contained contaminants as identified in the 2008 survey.

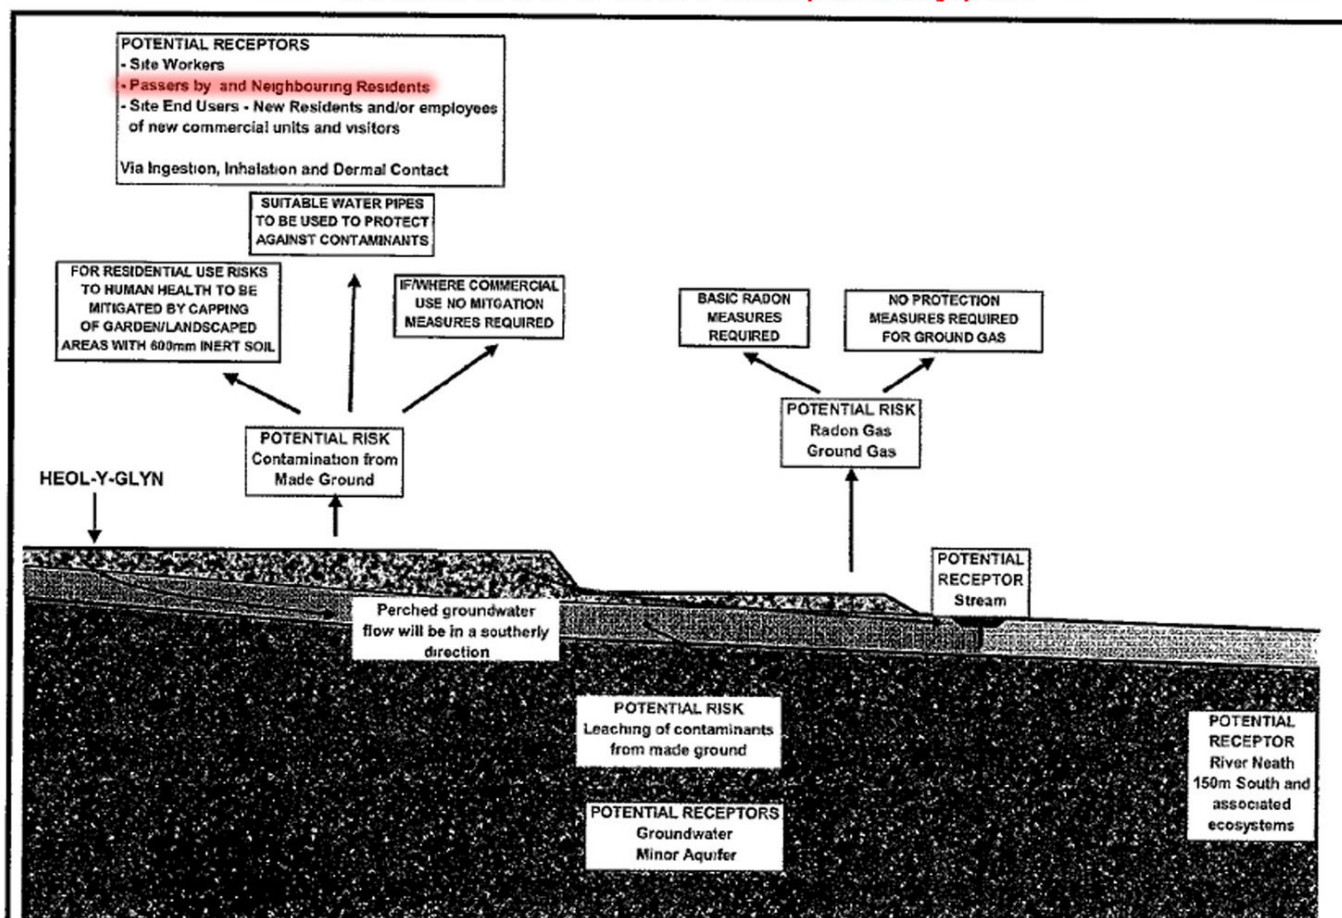
The illustration above shows the direction of groundwater which probably contained contaminants. This groundwater flowed downhill to Brynhyfryd and Woodland Park and has also possibly contaminated home grown produce.

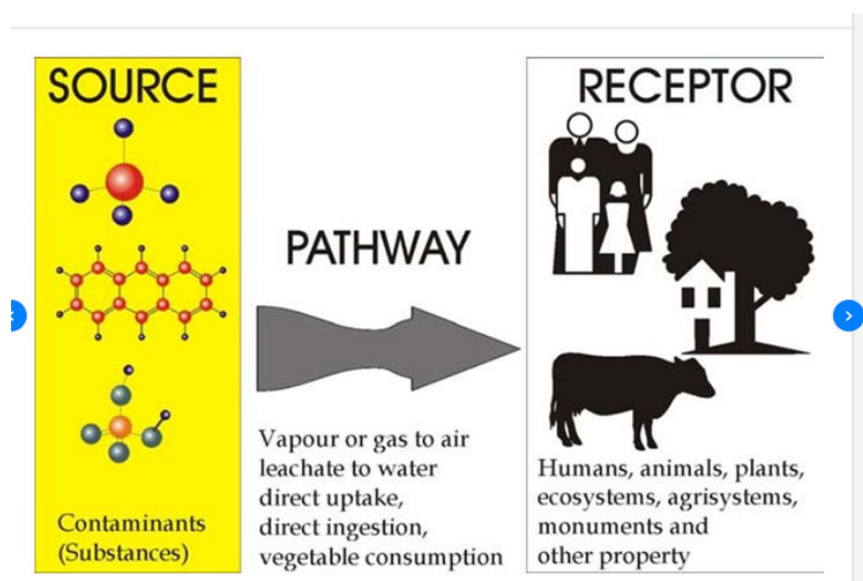
The illustration below shows an overview of the Source – Pathway – Receptor system. This appears in this document for information purposes only.
